DEPARTMENT OF NATURAL RESOURCES
DIVISION OF OIL, GAS AND MINING

RE: Site Inspection, San Rafael Energy, Inc., Four Corners Mine, M/015/014, Emery County, Utah

Date of Inspection: October 9, 1998
Time of Inspection: 1245 - 1520
Conditions: Sunny, warm, clear skies and gnats
Participants: Tony Gallegos, DOGM

Purpose of Inspection: To examine the reclaimed mine site and shaft closures in consideration of reclamation release

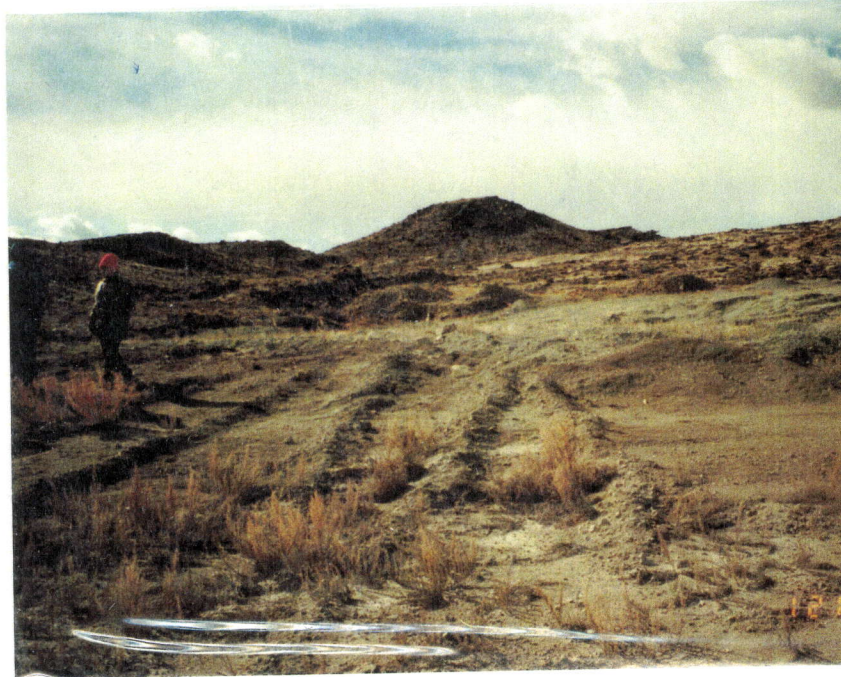
2 RECLAIMED AREA WHERE 2 BLDGS WERE LOCATED
